Intended Use:

To fix stiff footrest shelf issues.

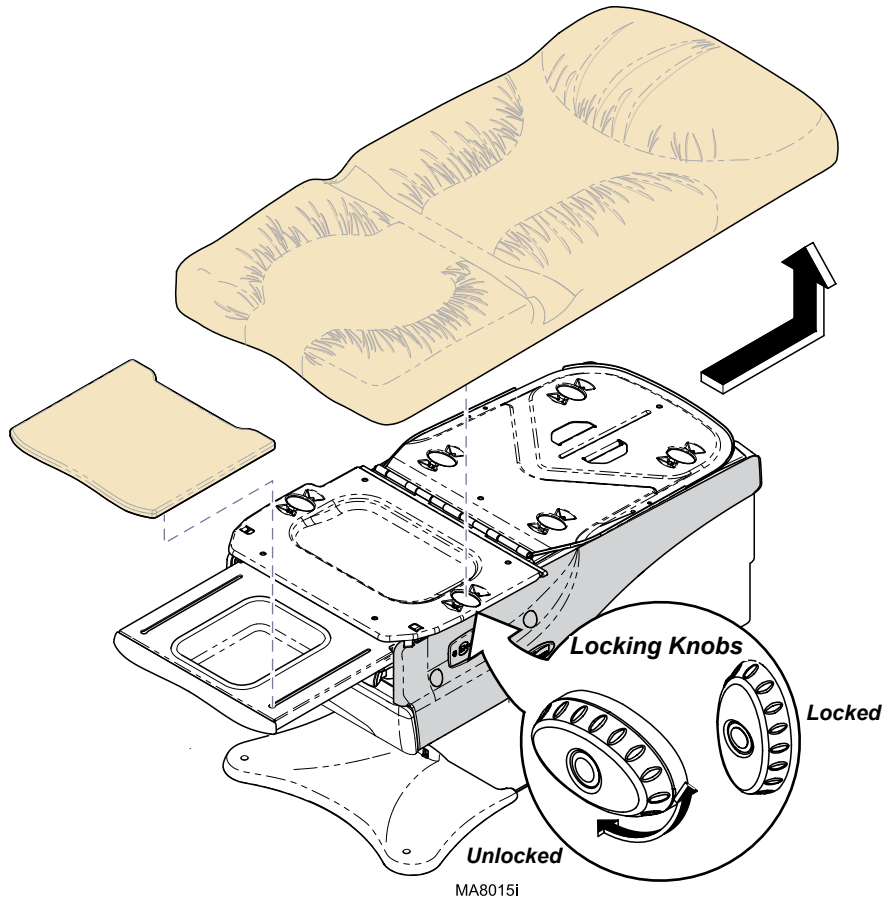
Step 1: Remove Upholstered Top & Footrest Pad.

- A) Rotate all locking knobs to unlocked position.
- B) Slide upholstery up to remove from back support plate.
- C) Pull up and remove footrest pad.

Note: There are four locking knobs under back section, and two locking knobs under seat section.

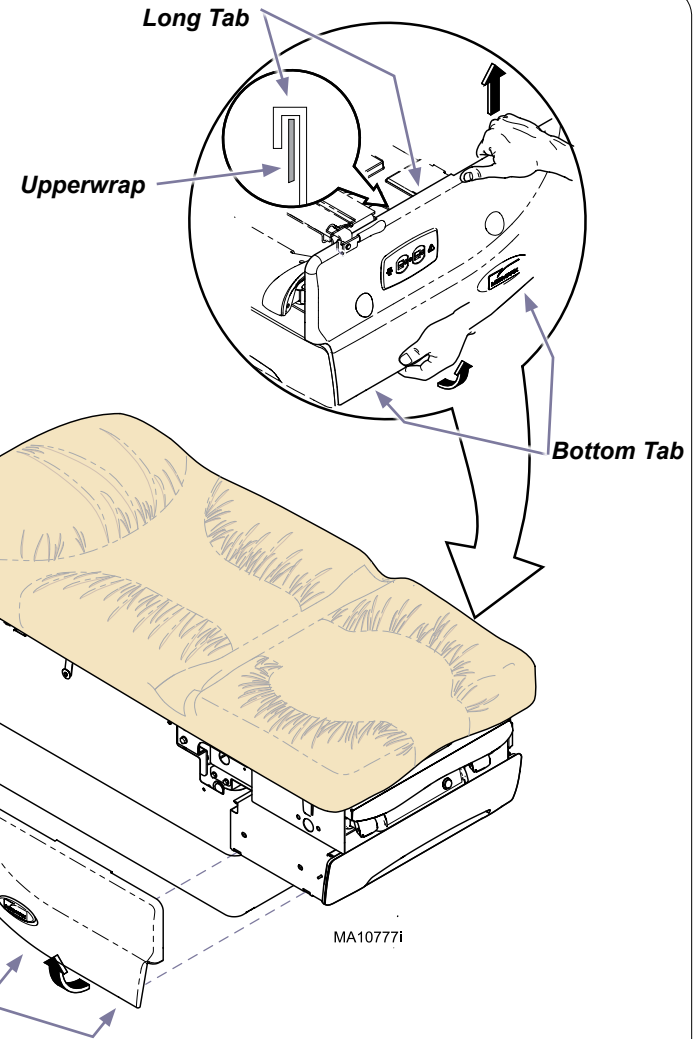
Note: 625 shown

Step 2: Remove Side Cladding.

- A) Press two tabs.
- B) Pull bottom of cladding away from table.
- C) Lift cladding up to remove.

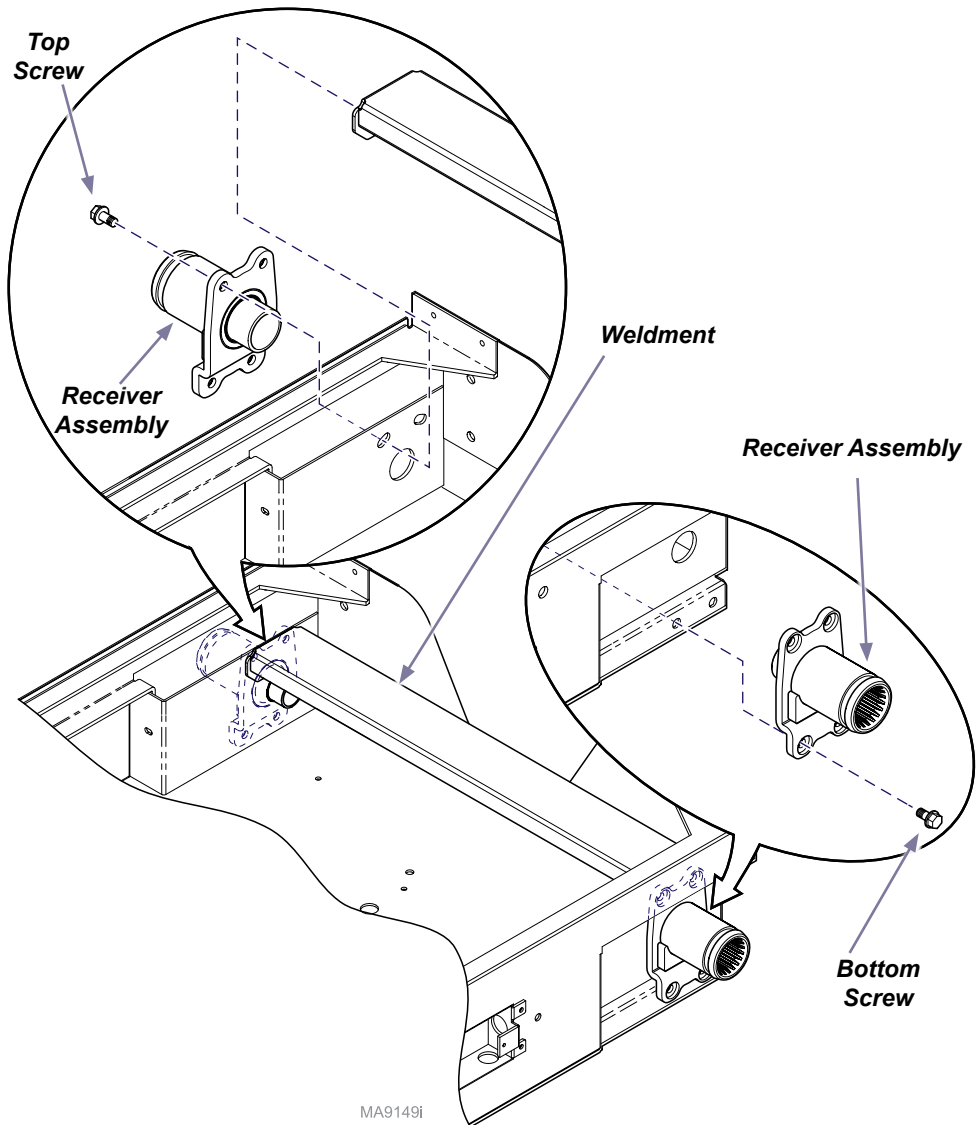
Step 3: Remove Receiver Assemblies & Weldment if Equipped.

A) Remove top (locking) and bottom (thread forming) screws.

B) Remove Receiver Assemblies and Weldment.

Note: Keep screw styles separate so correct screws are installed to the top and bottom of the receiver assembly during reinstallation.

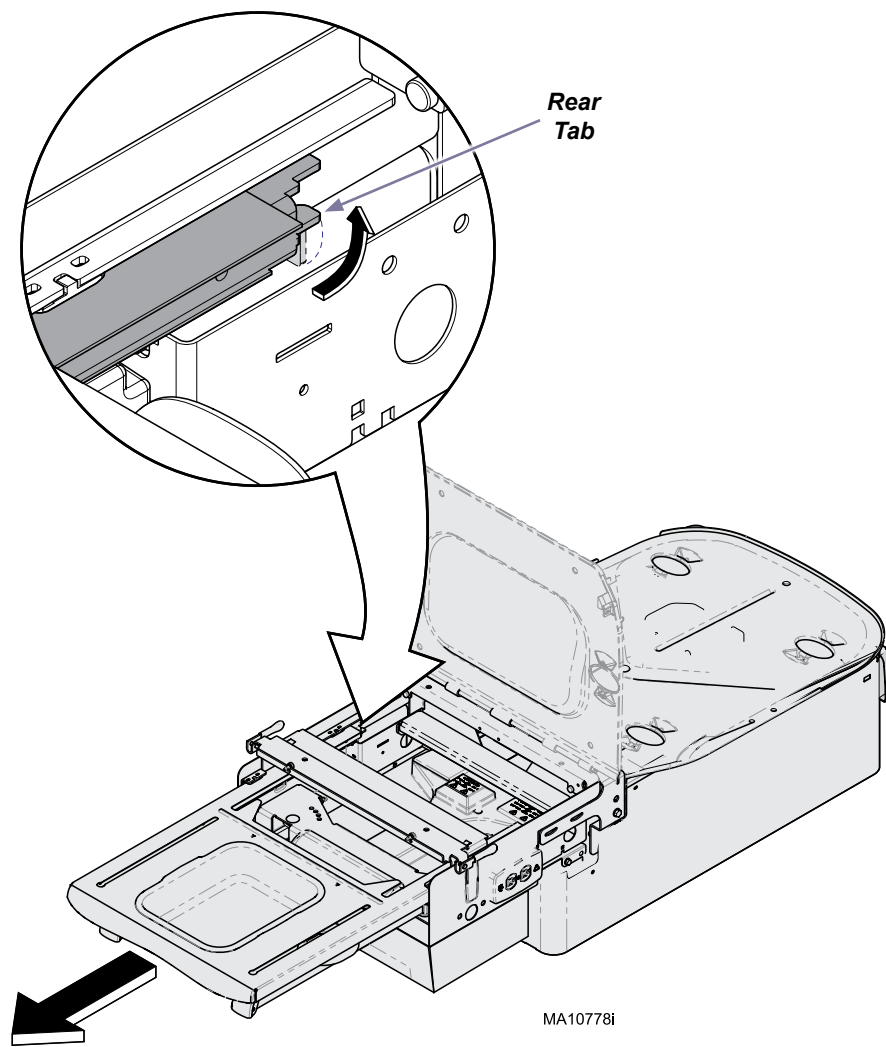
Step 4: Bend Rear Tabs Up and Remove Footrest.

A) Slide out Footrest and locate Rear Tabs.

B) Use vice grips or channel locks to bend tab straight. Repeat on opposite side.

C) Slide Footrest out and remove.

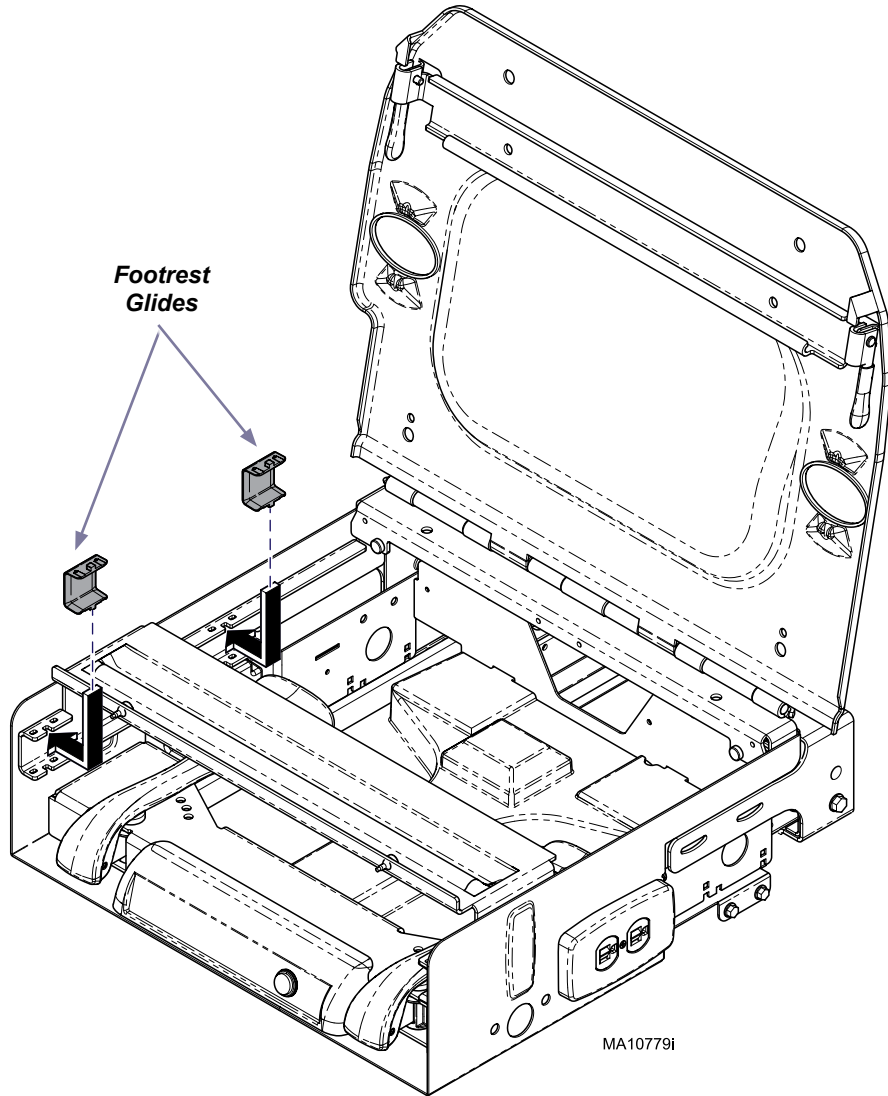
Step 5: Remove/Replace Footrest Glides.

- A) Press down on center tab of glide and remove. Repeat for all four glides.
- B) Insert four new glides.

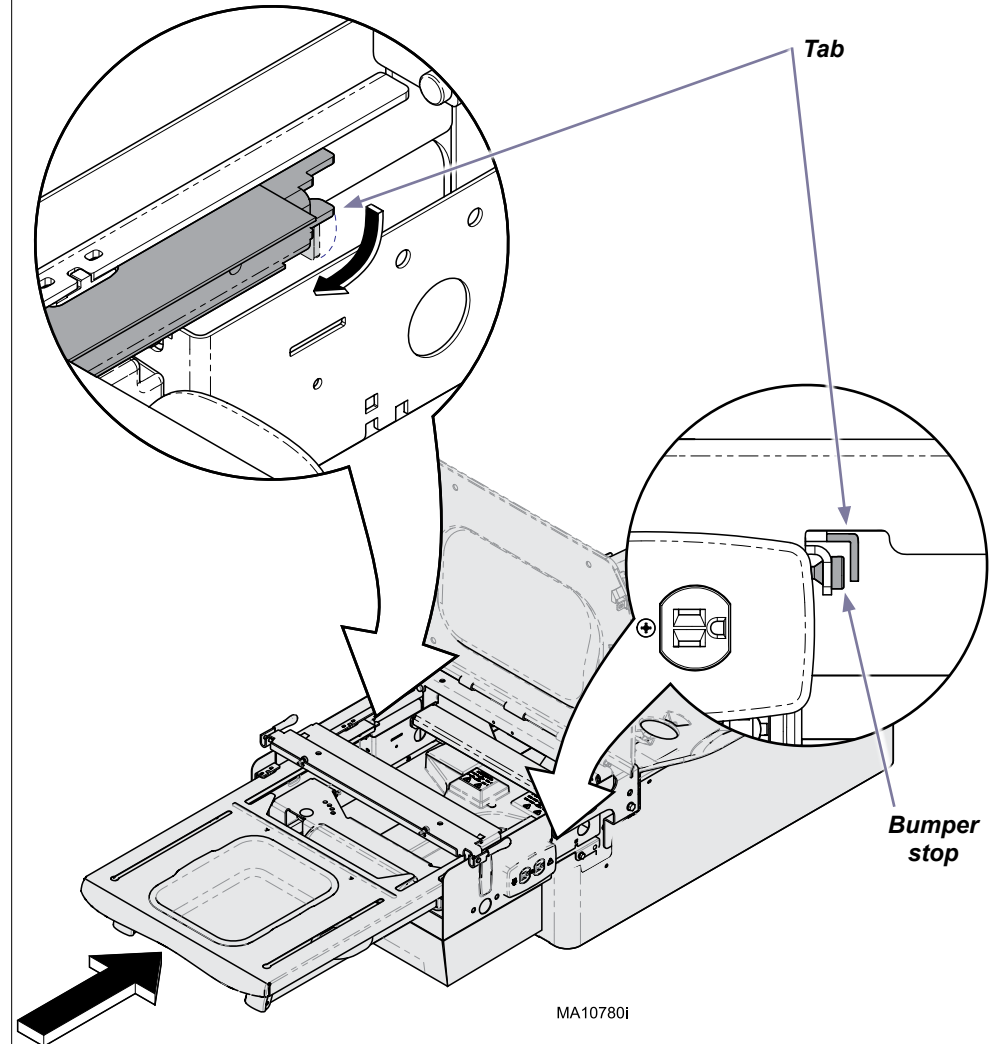
Step 6: Install Footrest, Bend Down Tab and Reassemble. (Reverse Order)

- A) Install Footrest and bend tabs Down 90° into original position.
- B) Install Receiver Assemblies and Weldment if equipped.
- C) Install Side Cladding.
- B) Install Upholstered Top & Footrest Pad.

Note: Check that tabs engage bumper stops when footrest is pulled out to full extension.
