# Intraoral Dental X-Ray System: Replacing the Horizontal Arm

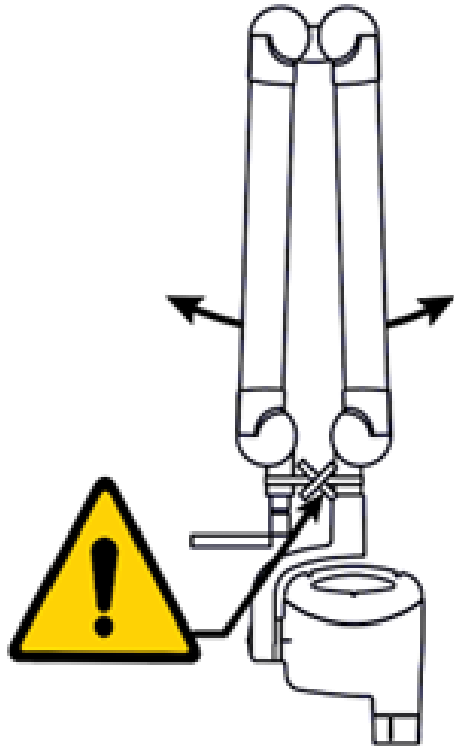
The Articulated Arm could spring open and cause serious injury if not secured using the provided tie prior to removal from the horizontal arm. Consult the Installation and Service Manual for guidance on all steps necessary to complete installation.
